International Charter Space and Major Disasters

Charter Activation # 415

Disaster Event Flood

Disaster Location North Region of Brazil

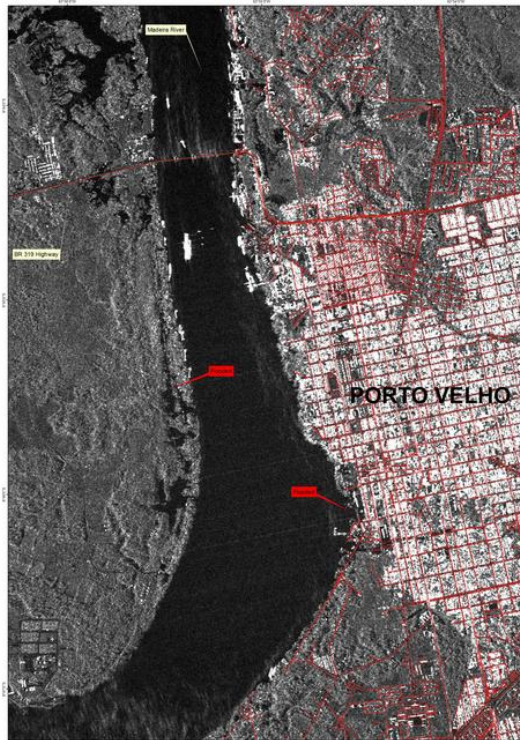
TerraSAR-X 24/MAR/2014

BRAZIL - Porto Velho / RO - FLOOD - 24-29/MAR/2014 TerraSAR-X / Pleiades IMAGE

Source: DLR - TerraSAR-X
 Acquired: 24/03/2014
 Acquisition mode: HR
 Resolution: 3.75 m
 Copyright: TerraSAR-X/AT/CESR/M 2014 German Aerospace Center (DLR), 2014 Airbus Defence and Space/Infoterra GmbH

02/04/2014: map released to EU over Porto Velho – new RISAT-1 (25/03/2014) and archive LANDSAT-8 (27/08/2013);
map released to EU over Porto Velho – new Pleiades (29/03/2014) and new TerraSAR-X (24/03/2014);

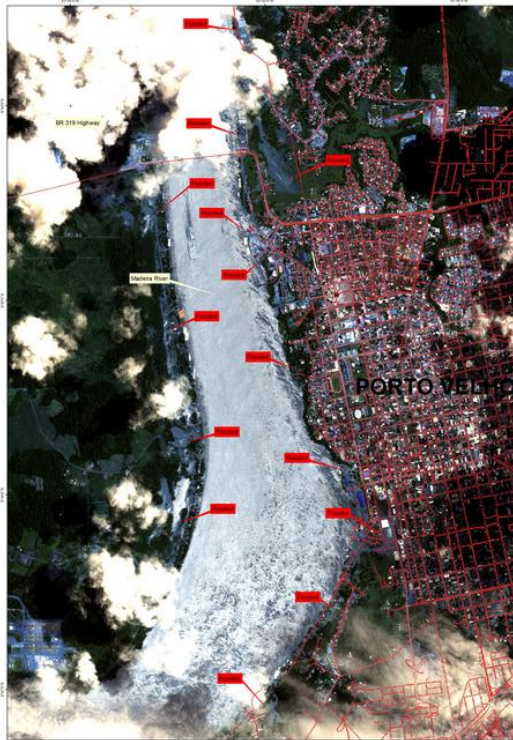
Pleiades - 29/MAR/2014

Source: Pleiades
 Acquired: 29/03/2014
 Resolution: 2 m
 Copyright: CNES 2014, 2014 Airbus Defence and Space
 Bands: 1, 2 and 3
 Composition: 3B-2B-1B

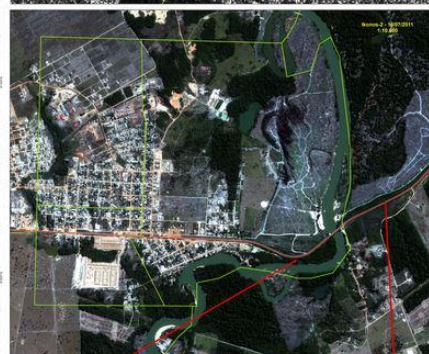
BRAZIL - FLOOD - Jaci-Paraná / RO - MAR/2014

Source: CSA - RADARSAT-2
 Acquired: 24/03/2014
 Acquisition mode: HRV
 Resolution: 10 m
 Compression: RADARSAT 2 Data and Products © MacDonald,
 Ltd. (www.mcdonalds.com) 2014
 RADARSAT is an official mark of the Canadian Space Agency

The event image
 Source: USGS - Sentinel-2
 Acquired: 14/03/2014
 Compression: 80:10:10

27/03/2014: map released to EU over Porto Velho – new TerraSAR-X (24/03/2014) and archive TerraSAR-X (14/12/2012) and LANDSAT-8 (27/08/2013);
map released to EU over Jaci-Parana – new RADARSAT-2 (25/03/2014) and archive IKONOS-2 (16/07/2011);
