International Charter Space and Major Disasters

Charter Activation 478

Disaster Event Dam collapse and Flooding in Brazil

PM Report

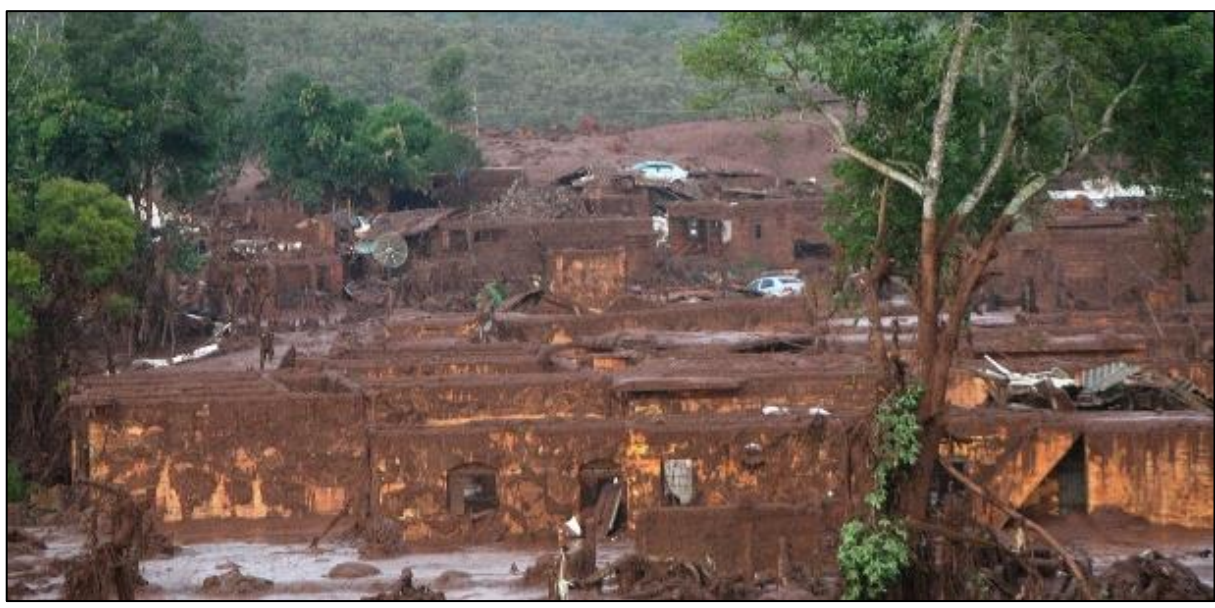
Bento Rodrigues foi tomado pela lama que saiu das barragens e ficou devastado
