São Sebastião (Boiçucanga/Camburi) - SP
Geomorphological Processes - Scars and Deposits
Charter Activation 803
2023-03-05

Landslides inferred from post-disaster image HIRI/Pleiades 1A-25.02.2023
Contour lines extracted from JAXA/METI ALOS PALSAR AP26854_FBS_F6700

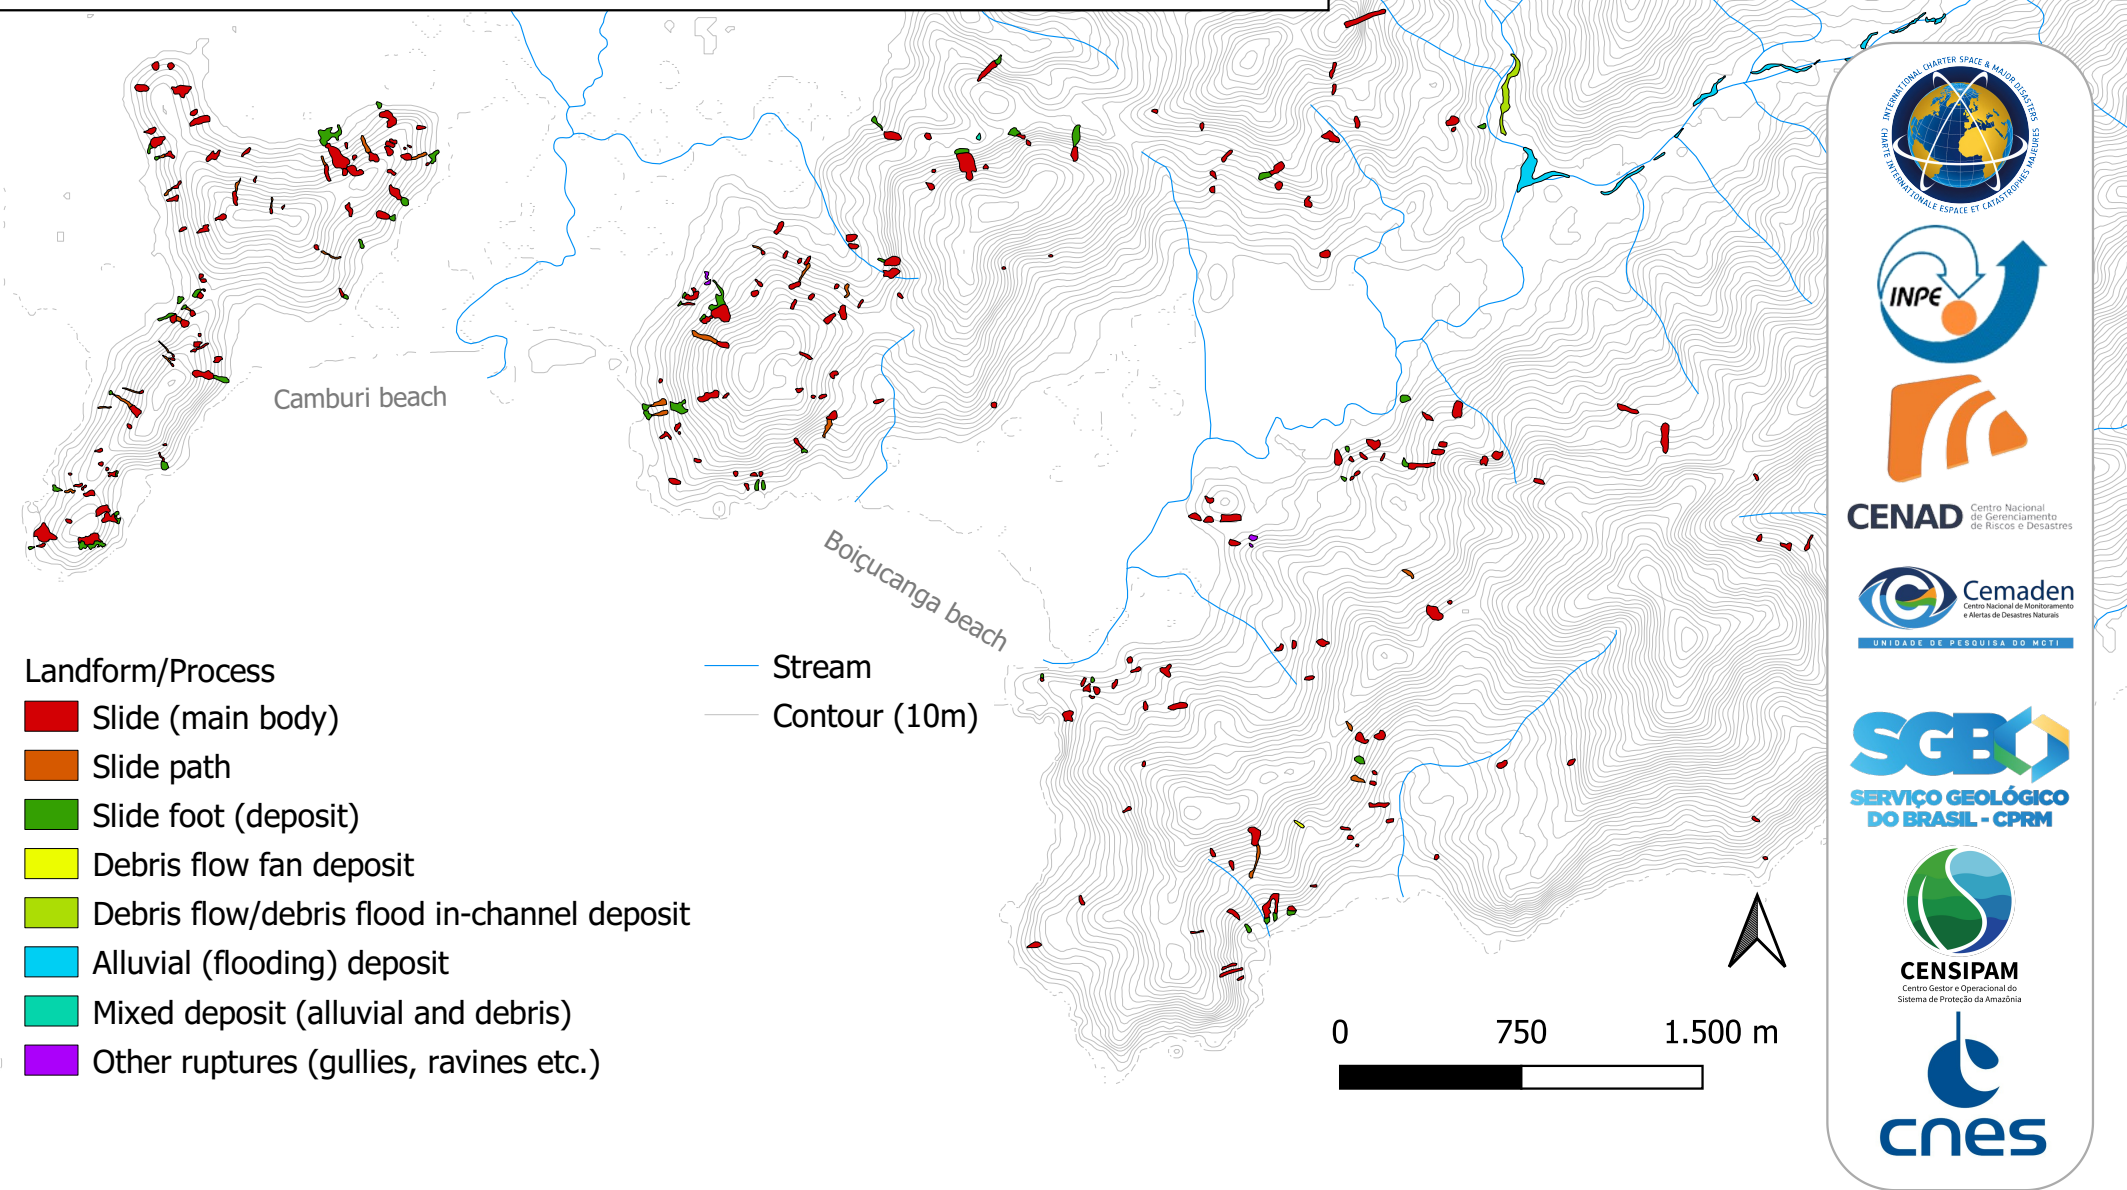
- Landform/Process
- Slide (main body)
 - Slide path
 - Slide foot (deposit)
 - Debris flow fan deposit
 - Debris flow/debris flood in-channel deposit
 - Alluvial (flooding) deposit
 - Mixed deposit (alluvial and debris)
 - Other ruptures (gullies, ravines etc.)
