Flood in Abukuma River basin at Marumori and Kakuda

Data Source
Image: CBERS-4
Image Date: 14th Oct 2019
Image copyright: Instituto
National de Pesquisas
Espaciais-INPE

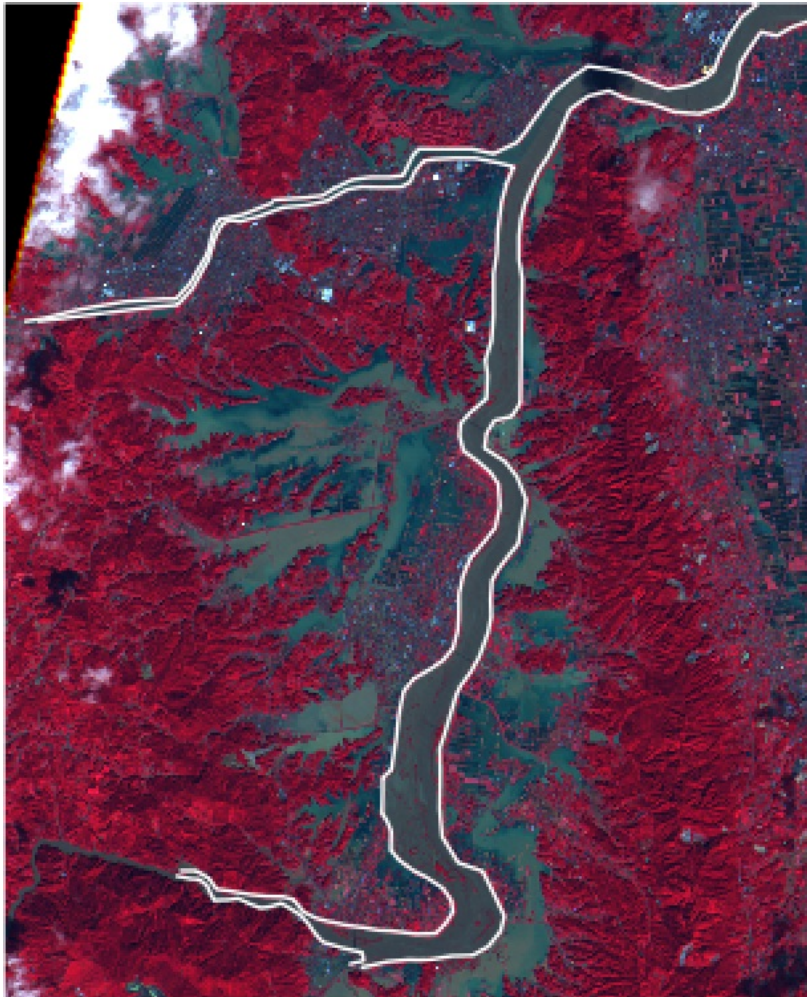
false color

White line embankment, river boundary

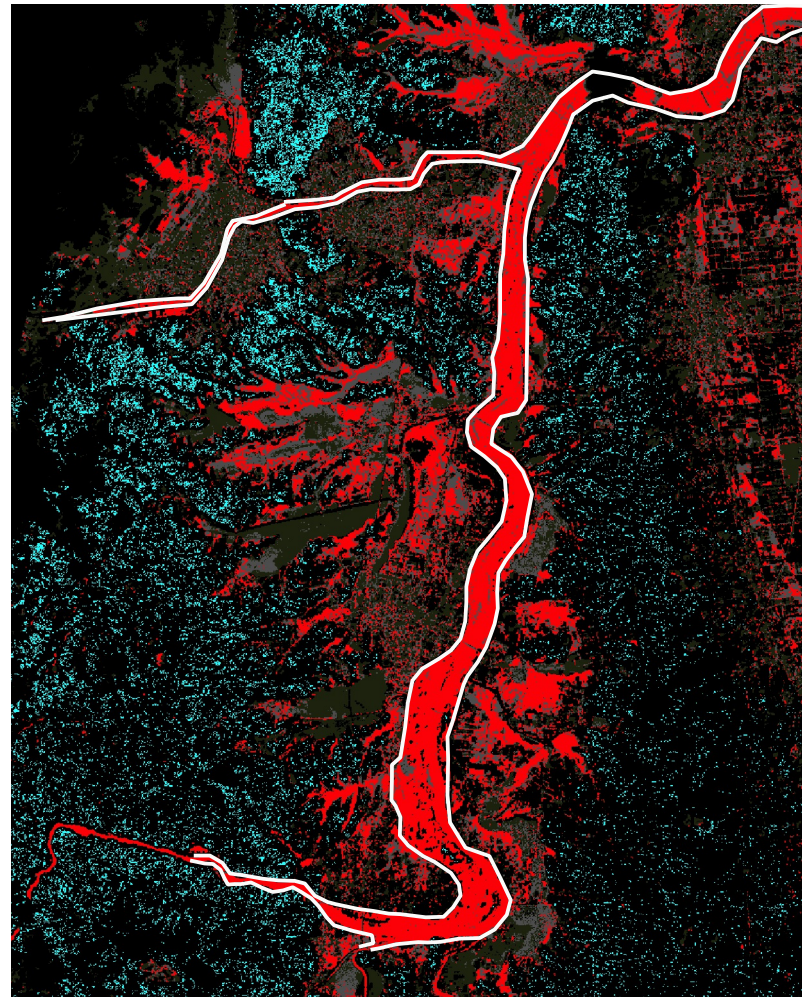
classification

- 1 - water(possible of flood)
- 2 - veg
- 3 - other
